KENT COASTAL ANALYSIS

SHEPWAY - ASSESSMENT OF SUPERFLUOUS SIGNS

December 2011

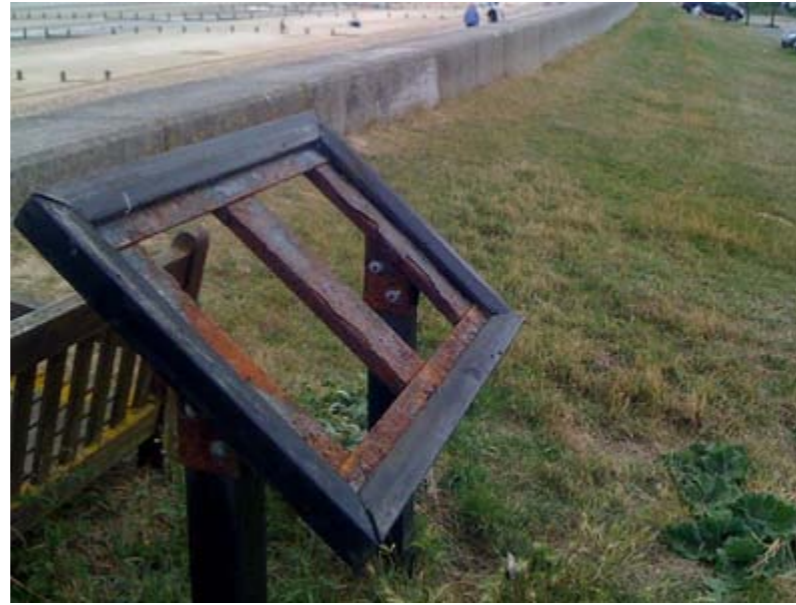
L24: Interpretation Board:

Abandoned.

Proposal: Remove or replace

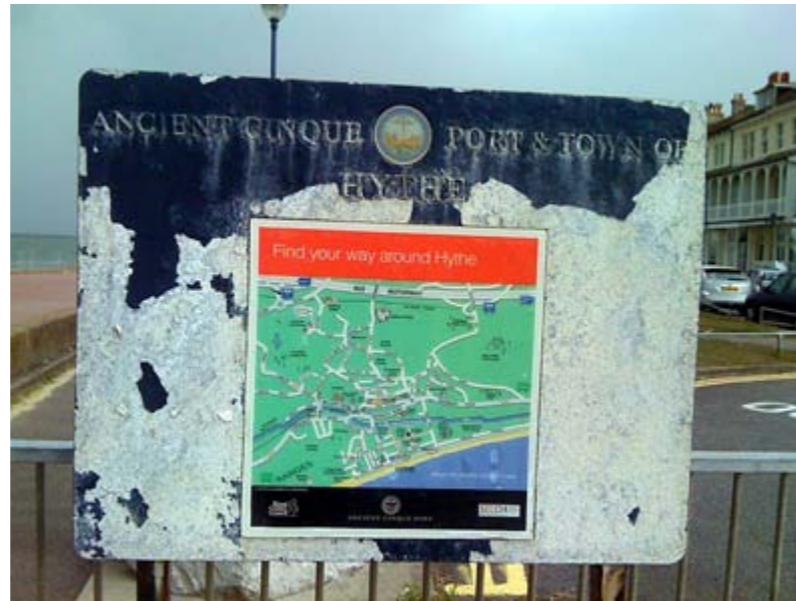
G9: Map Board:

Partially abandoned.

Proposal: Remove or replace

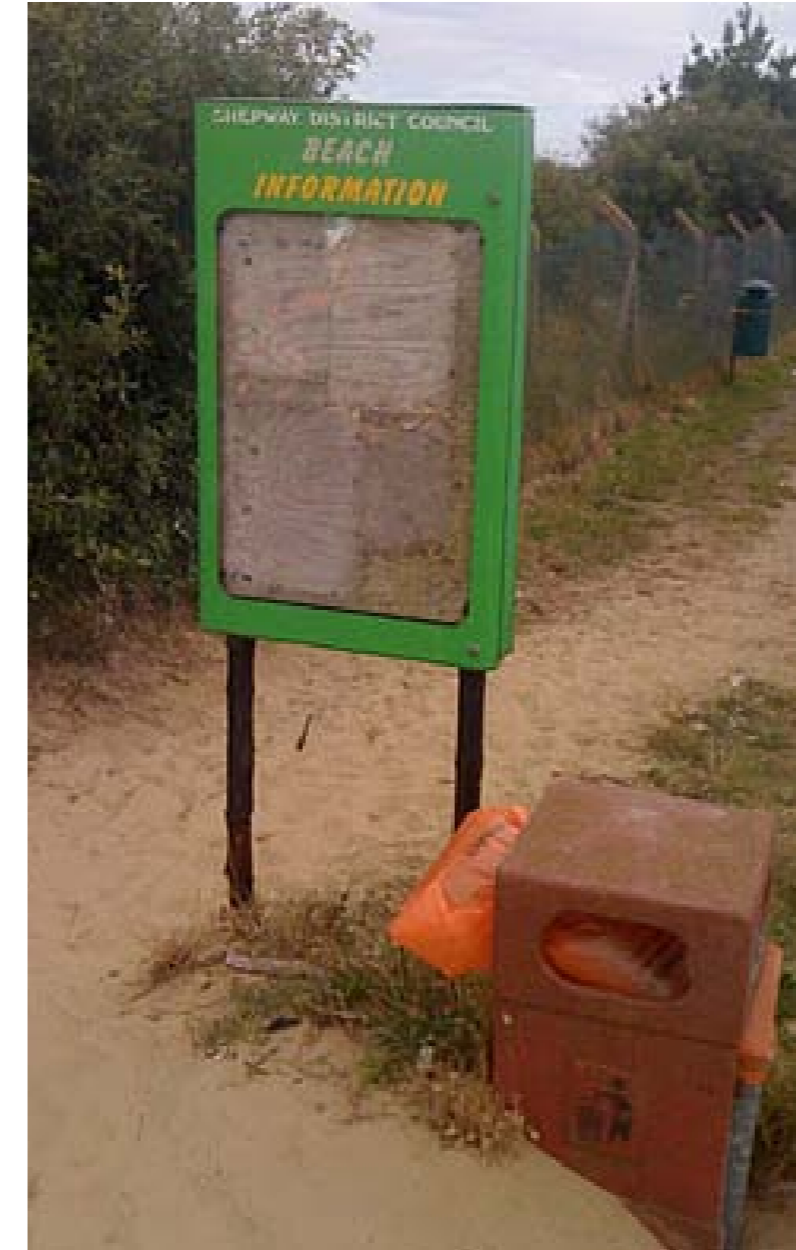
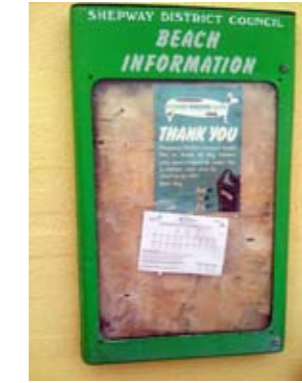
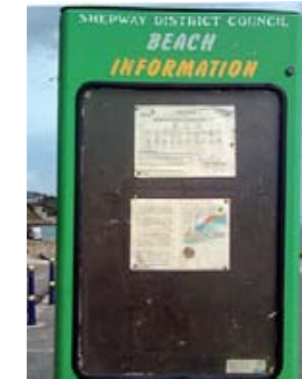
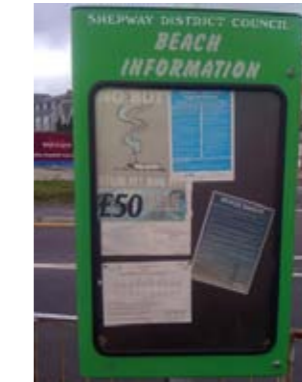
M38 (main picture), E14, C3 and F8 Beach Information Boards:

Under-used, tired, unattractive.

Proposal: Remove and replace with new beach information signs such as F6, F4I and G5 (see below)

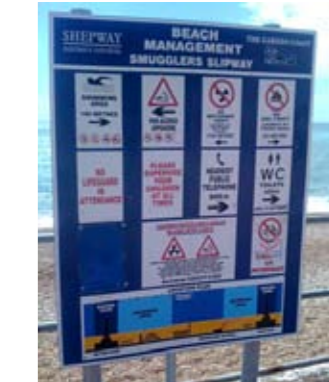
F4I Beach Management Sign

Contains a lot of information, some negative but it is coordinated, clear and well placed.

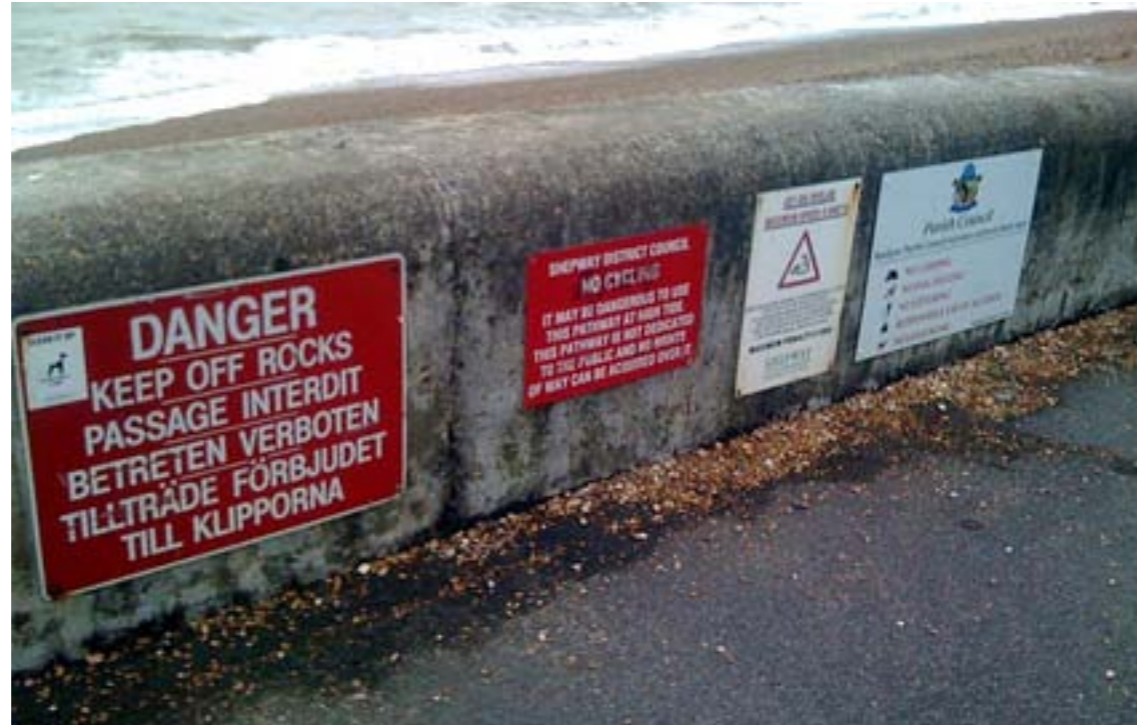
E21 (main picture), E1 and E16: Negative, clutter, some duplication and three organisations.

Proposal: Coordinate with all parties into one sign with a more positive spin.

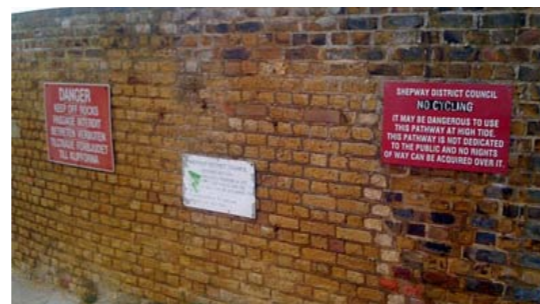
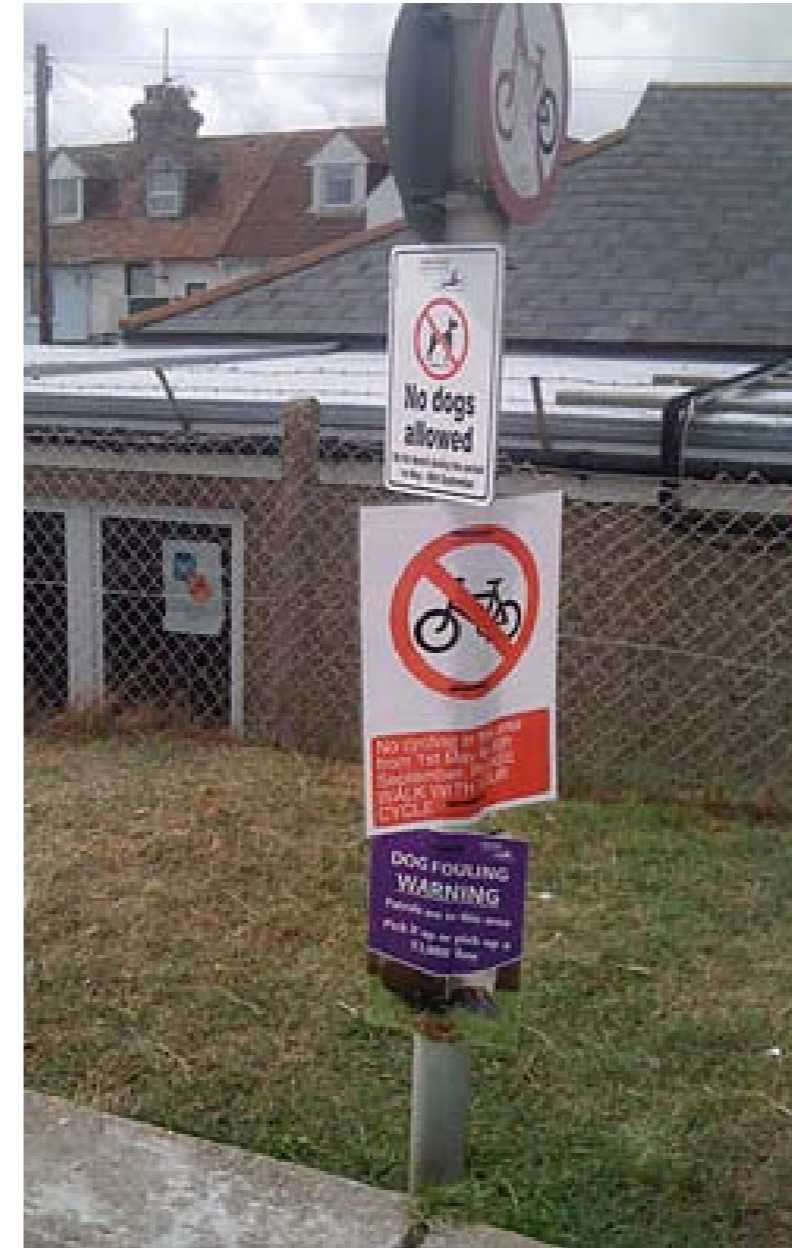
K11 No cycling and dog fouling signs:

Duplication and poor quality.

Proposal: Whilst the principle of utilising a single pole for more than one sign is good this is clearly unsightly and unnecessary. Remove lower two or preferably all of it.

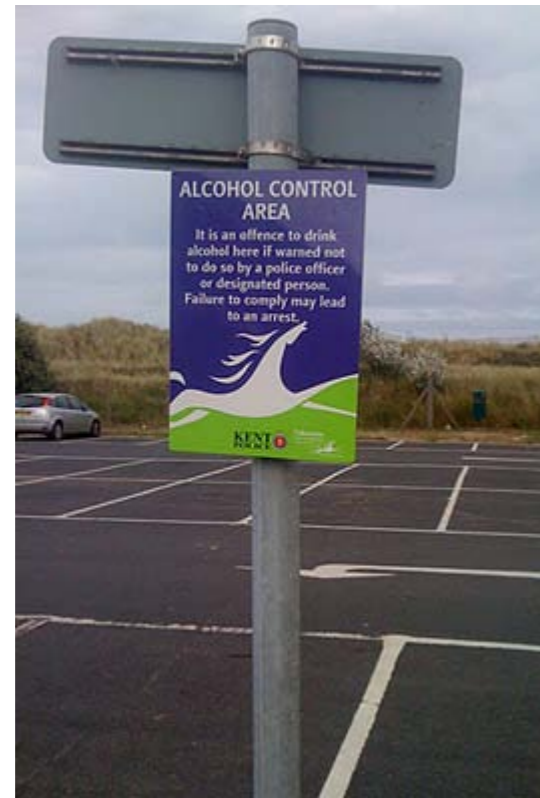
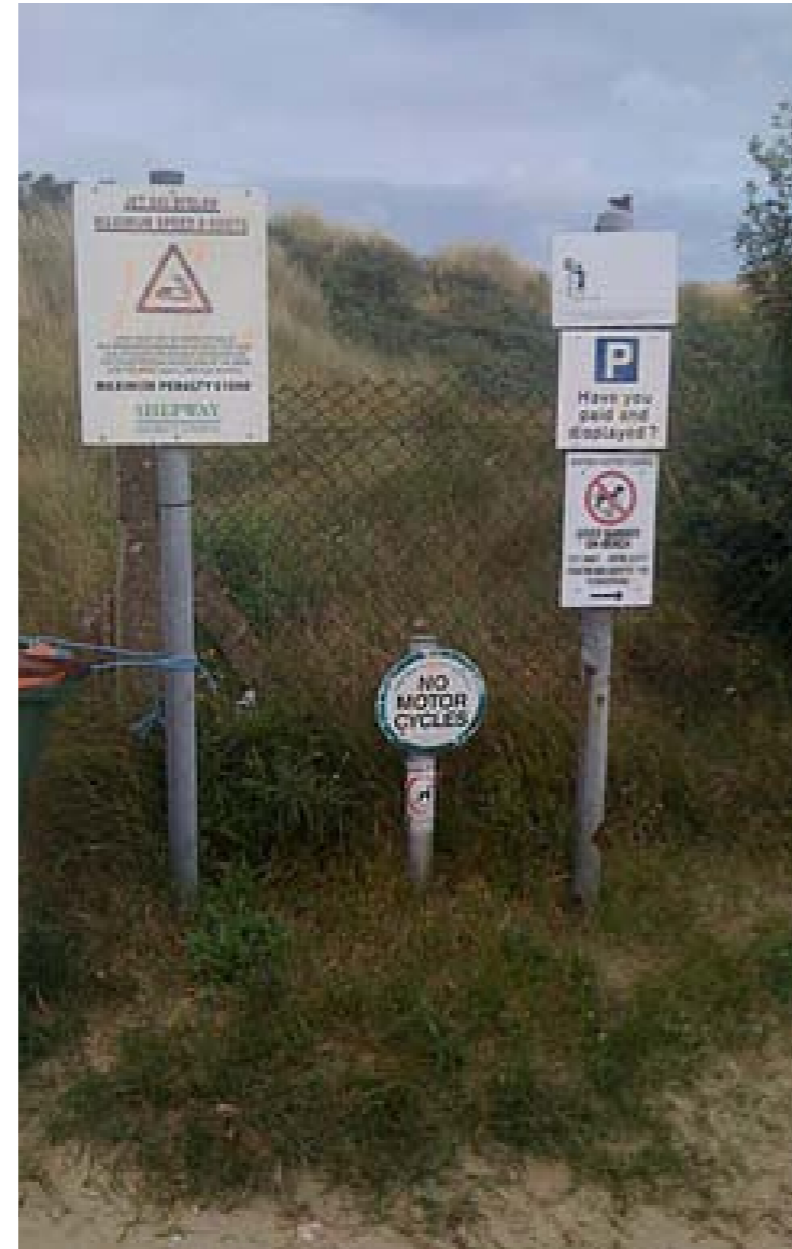
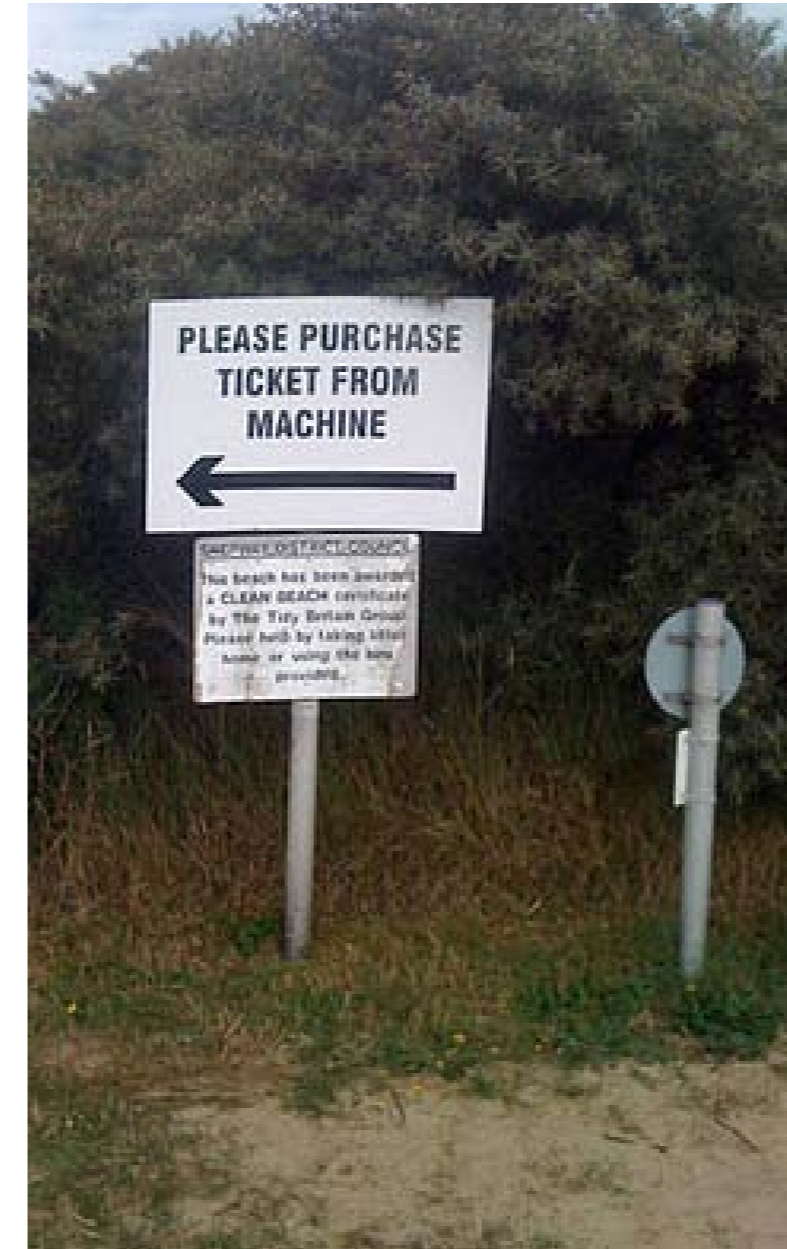
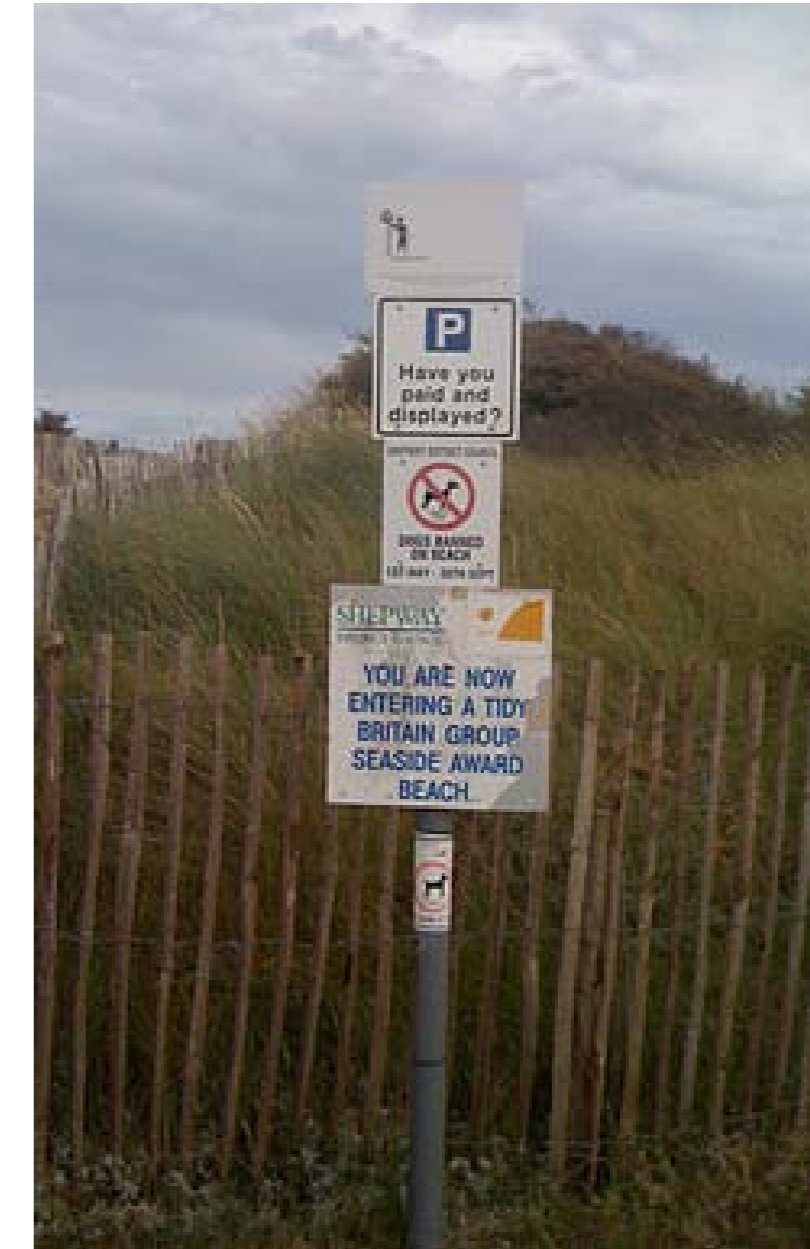
M38 a-d Various signs in the same location:

Clutter, duplication and poor quality.

Proposal: Whilst the principle of utilising a single pole for more than one sign is good this is clearly unsightly and unnecessary. As a minimum remove 'Tidy Britain Award' signs, dog signs and old byelaw signs. Preferably rationalise and replace all into one coordinated sign system.

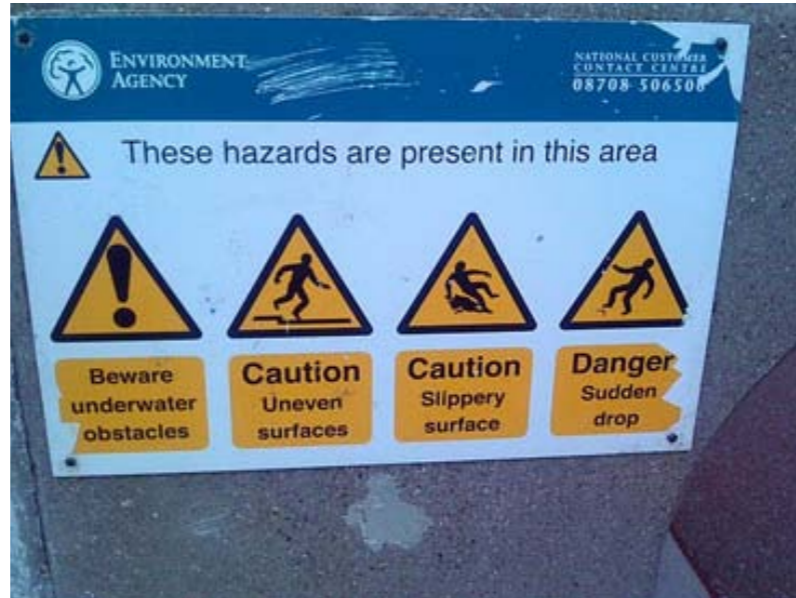
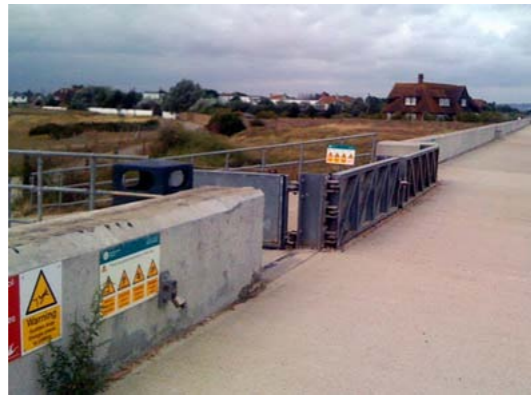
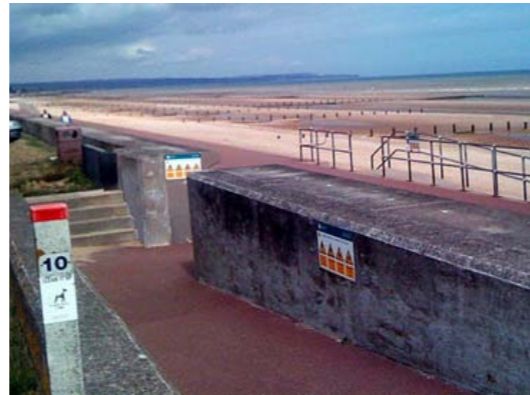
L12 (main picture), L8 and L43: Environment Agency warning signs

Negative and over-signed

Proposal: Reduce number by half. Consider more positive tone when due for replacement

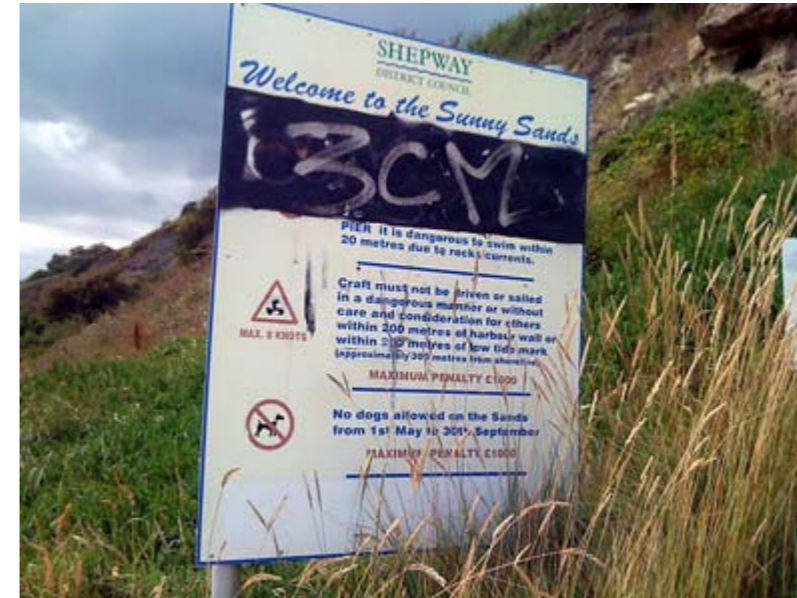
B4 Sunny Sands Welcome Sign

More negative than welcoming. Unattractive and vandalised.

Proposal: Replace with new design of welcome sign and re-locate any necessary 'directive' messages elsewhere.

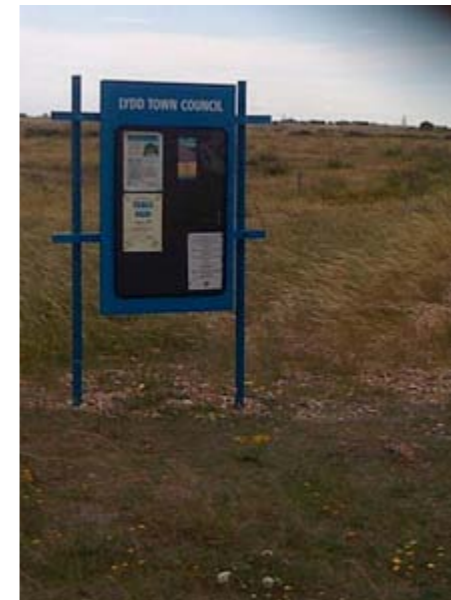
NI Lydd Town Council Notice Board

Unattractive and appears poorly located. Unlikely to be read much in this location?

Proposal: Replace with new design and re-consider location.
